BOLU TAŞINMAZ KÜLTÜR VE TABİAT VARLIKLARI ENVANTERİ

MUDURNU İLÇESİ - SİVİL MİMARİ YAPILAR

ADI	Haytalar Konağı-Konut		
ENVANTER NO	42	KADASTRAL DURUMU	
İLİ	Bolu	PAFTA	26-27-Dc
İLÇESİ	Mudurnu	ADA	182
MAHALLESİ	Büyükcami Mahallesi	PARSEL	20
TESCİL DURUMU	Ankara Kültür ve Tabiat Varlıklarını Koruma Kurulu'nun 16.10.1995 tarih ve 4219 sayılı kararı ile tescil edilmiştir.

BOLU IMMOVABLE CULTURAL AND NATURAL HERITAGE INVENTORY**MUDURNU DISTRICT – CIVIL ARCHITECTURE STRUCTURES**

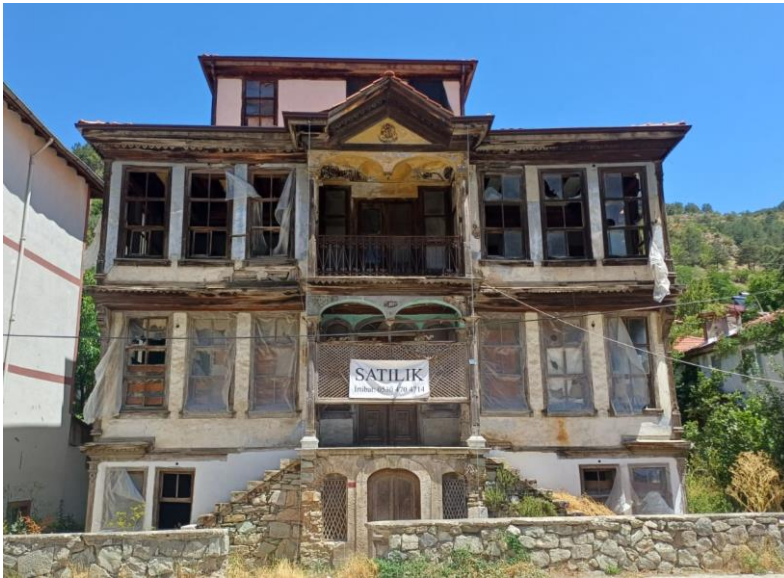
Haytalar Konağı, Bolu Müze Müdürlüğü Arşivi

Bolu İli, Mudurnu İlçesi, Büyükcami Mahallesi, Yukarıhamam Sokak, 26-27-Dc pafta, 182 ada, 20 parselde yer alan bina zemin + 2 katlı ve cihannümalıdır. Yapı tekniği ahşap karkas arası dizeme üstü sıvalıdır. Batı cephesinde Yukarıhamam Sokaktan giriş alan yapıda zeminde yükselen çift taraflı taş basamaklı merdiven giriş sahanlığında bulunur. Zeminde bir merdivenin altında bir kemerli kapı, bunun sağında ve solunda iki kemerli ve ahşap kafesli pencere, odunluğa açılan merdivenin solunda ve sağında 2 tane dikdörtgen pencere yer alır. Birinci katta sahanlıktan çift kanatlı ahşap bir kapı ile giriş sağlanır. Sahanlığın üstü iki ahşap dikmeyle desteklenen balkon ile kaplanmıştır. Ayrıca sahanlıkta sokaktan görüntüyü kesmek amacıyla ahşap dikmeler arasında iki tane kafes yer almaktadır. Bu kafeslerin üstünde ahşap geometrik süslemeler bulunmaktadır. Balkonun altı kemer şeklinde dilimlendirilmiştir. Kemer köşelikleri kalem işi bitkisel süslemelerle bezenmiştir. Üçgen alınlıkta "Maşallah", 1. katta kemer sırasının ortasında ise "Sene 1323" (M. 1905) ibaresi okunmaktadır. 2. kat çıkma şeklinde düzenlenmiştir. Çıkmaların altı ahşap kaplı olup, uçlarında zikzak ahşap işlemler vardır. 1. ve 2. katlarda dikdörtgen formlu giyotin pencereler mevcuttur. Çatıda enlemesine dikdörtgen planlı, profilli saçak altı olan cihannüma üzerinde de dikdörtgen formlu renkli camlı pencereler kullanılmıştır.

Çatı kırma ve alaturka + çinko kaplı olup, saçak altı ahşap kaplanmıştır.

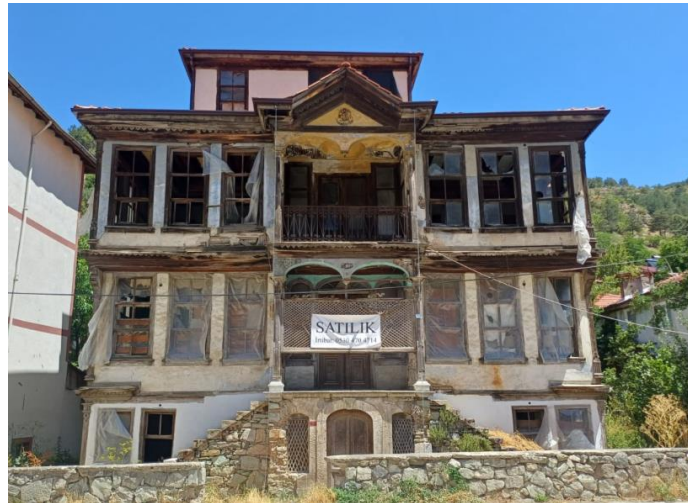
Haytalar Mansion, Bolu Museum Directorate Archive

The building, located in Bolu Province, Mudurnu District, Büyükcami Neighborhood, Yukarıhamam Street, sheet 26-27-Dc, block 182, plot 20, consists of a ground floor and two upper floors and includes a cihannüma, which is a projecting room with panoramic windows. The construction technique consists of a wooden frame with infill, covered with plaster. The entrance to the building is located on the west façade, accessible from Yukarıhamam Street via a double-sided stone stair that leads to the landing. On the ground floor, beneath the staircase, there is an arched door; to the left of this door are two arched wooden lattice windows. There are two rectangular windows on each side of the staircase leading to the woodshed. Access to the first floor is provided through a double-leaf wooden door from the landing. The landing is covered by a balcony supported by two wooden posts. Additionally, to obstruct the street view from the landing, two wooden lattices are placed between the posts. On these wooden lattices, there are geometric wooden decorations. The underside of the balcony is divided into arch-shaped segments. The spandrels of the arches are decorated with painted vegetal motifs. On the triangular pediment, the inscription 'Maşallah' is visible, while at the center of the arch row on the first floor, the inscription 'Sene 1323' (A.D. 1905) can be read. The second floor is designed as a cantilevered projection. The underside of the projection is clad in wood and decorated with zigzag-shaped woodwork at the edge. Rectangular guillotine windows are used on both the first and second floors. On the roof, the transverse rectangular-plan cihannüma includes rectangular colored-glass windows beneath a profiled eave.

The hipped roof is covered with traditional Turkish pantiles and zinc sheets, while the underside of the eaves is lined with wood.
