**BOLU TAŞINMAZ KÜLTÜR VE TABİAT VARLIKLARI ENVANTERİ****MUDURNU İLÇESİ - SİVİL MİMARİ YAPILAR**

| ADI | Bökesoylar Konağı-Konut | | |

**BOLU IMMOVABLE CULTURAL AND NATURAL HERITAGE INVENTORY****MUDURNU DISTRICT – CIVIL ARCHITECTURE DISTRICT**

| <b>NAME</b> | Bökesoylar Mansion-Residence | | |

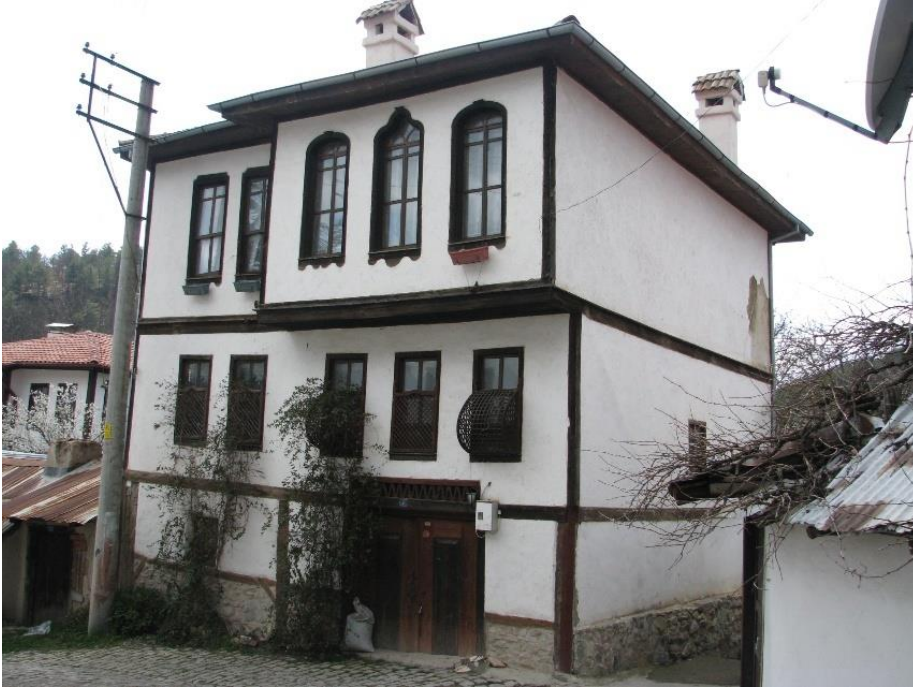
Bolu İli, Mudurnu İlçesi, Hızırfağı Mahallesi, Değirmen Sokak, 30-27-Ad pafta, 207 ada, 10 parselde yer alan yapı zemin + 2 katlıdır. Zemini taş yığma olan yapı, ahşap karkas arası dizeme üstü sıvalıdır. Değirmen Sokaktan çift kanatlı ahşap kapı ile girilir. Kapının üstünde boyunca uzanan ışıklığın üstü ahşap zikzak kafesle örtülüdür. Kapının sol yanında küçük bir servis penceresi vardır. 1. katta ahşap pencereli dikdörtgen pencereler bulunmaktadır. 2. katta sağ köşede ahşap merteklerin uzatılmasıyla yapılmış çıkma üzerinde basık kemerli ve ortada dilimli kemerli dikdörtgen pencereler vardır. 2. kattaki pencere altları dilimli ahşap süslemeler ile bezenmiştir. Sağ yan cephe 1. kattaki küçük servis penceresi hariç sağır bırakılmıştır. Sol yan cephede zemin sağırdır ve arka taraf yarıdan itibaren çıkma şeklinde düzenlenmiştir. Sadece ön cephe ve sağ taraftaki cephe sıvalıdır. Kat aralarında ahşap silme, köşelerde ahşap dikmeler yer alır.

Kırma çatı, alaturka kiremitle kaplıdır. Saçak altı kaplamasızdır.

Bökesoylar Konağı, Bolu Müze Müdürlüğü Arşivi

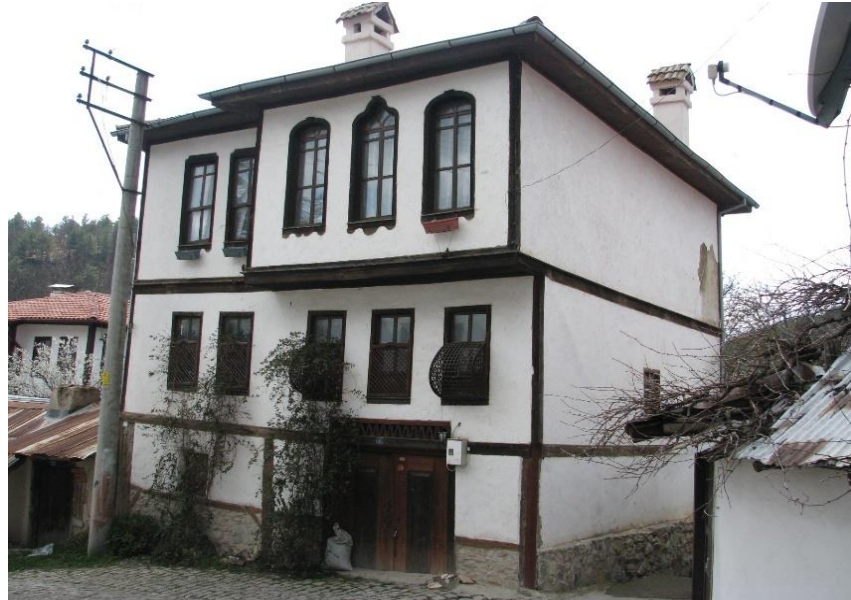
The structure located on Sheet 30-27-Ad, Block 207, Plot 10, in Bolu city, Mudurnu district, Hızırfağı Neighborhood, Değirmen Street is a two-storey structure with a ground floor. The construction technique consists of plastered masonry infill between a wooden frame resting on a stone foundation. A skylight above the door features a zigzag-patterned wooden lattice. A service window is present to the left of the door. The first floor features wooden-framed rectangular windows, while the second floor has rectangular windows with segmental arches and a centrally lobed arch on the oriel. Windowsills on the second floor are decorated with lobed wooden ornaments. The right-side facade is a blank wall except for a small window on the first floor. The ground on the left side facade is a blank wall and rear side is constructed as a cantilevered projection starting from the middle onward. Only the front facade and the right facade are plastered. Timber tie beams are installed between the floors, and wooden posts are utilized at the corners.

The hipped roof is covered with Anatolian pantiles. The eaves soffit is left unclad.

Bökesoylar Mansion, Bolu Museum Directorate Archive
