BOLU TAŞINMAZ KÜLTÜR VE TABİAT VARLIKLARI ENVANTERİ

MUDURNU İLÇESİ - SİVİL MİMARİ YAPILAR

BOLU IMMOVABLE CULTURAL AND NATURAL HERITAGE INVENTORY

NAME	Haytalar Mansion-Residence		
ENVANter NO	42	CADASTRAL INFORMATION	
PROVINCE	Bolu	SHEET	26-27-Dc
DISTRICT	Mudurnu	BLOCK	182
NEIGHBORHOOD	Büyükcami Neighborhood	PLOT	20
REGISTRATION STATUS	It was registered by the Ankara Cultural and Natural Heritage Conservation Board with decision no. 4219 dated 16.10.1995.

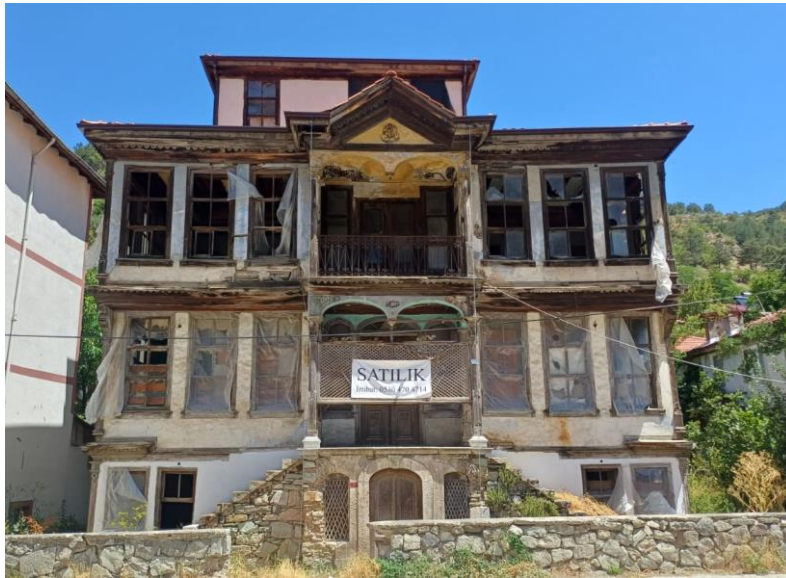
Haytalar Konağı, Bolu Müze Müdürlüğü Arşivi

Bolu İli, Mudurnu İlçesi, Büyükcami Mahallesi, Yukarıhamam Sokak, 26-27-Dc pafta, 182 ada, 20 parselde yer alan bina zemin + 2 katlı ve cihannümalıdır. Yapı tekniği ahşap karkas arası dizeme üstü sıvalıdır. Batı cephesinde Yukarıhamam Sokaktan giriş alan yapıda zeminde yükselen çift taraflı taş basamaklı merdiven giriş sahanlığında bulunur. Zeminde bir merdivenin altında bir kemerli kapı, bunun sağında ve solunda iki kemerli ve ahşap kafesli pencere, odunluğa açılan merdivenin solunda ve sağında 2 tane dikdörtgen pencere yer alır. Birinci katta sahanlıktan çift kanatlı ahşap bir kapı ile giriş sağlanır. Sahanlığın üstü iki ahşap dikmeyle desteklenen balkon ile kaplanmıştır. Ayrıca sahanlıkta sokaktan görüntüyü kesmek amacıyla ahşap dikmeler arasında iki tane kafes yer almaktadır. Bu kafeslerin üstünde ahşap geometrik süslemeler bulunmaktadır. Balkonun altı kemer şeklinde dilimlendirilmiştir. Kemer köşelikleri kalem işi bitkisel süslemelerle bezenmiştir. Üçgen alınlıkta "Maşallah", 1. katta kemer sırasının ortasında ise "Sene 1323" (M. 1905) ibaresi okunmaktadır. 2. kat çıkma şeklinde düzenlenmiştir. Çıkmaların altı ahşap kaplı olup, uçlarında zikzak ahşap işlemler vardır. 1. ve 2. katlarda dikdörtgen formlu giyotin pencereler mevcuttur. Çatıda enlemesine dikdörtgen planlı, profilli saçak altı olan cihannüma üzerinde de dikdörtgen formlu renkli camlı pencereler kullanılmıştır.

Çatı kırma ve alaturka + çinko kaplı olup, saçak altı ahşap kaplanmıştır.

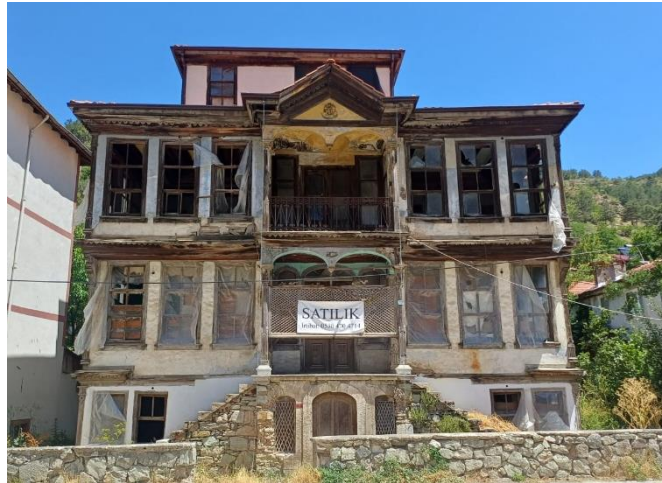
Haytalar Mansion, Bolu Museum Directorate Archive

The building, located in Bolu Province, Mudurnu District, Büyükcami Neighborhood, Yukarıhamam Street, sheet 26-27-Dc, block 182, plot 20, consists of a ground floor and two upper floors and includes a cihannüma, which is a projecting room with panoramic windows. The construction technique consists of a wooden frame with infill, covered with plaster. The entrance to the building is located on the west façade, accessible from Yukarıhamam Street via a double-sided stone stair that leads to the landing. On the ground floor, beneath the staircase, there is an arched door; to the left of this door are two arched wooden lattice windows. There are two rectangular windows on each side of the staircase leading to the woodshed. Access to the first floor is provided through a double-leaf wooden door from the landing. The landing is covered by a balcony supported by two wooden posts. Additionally, to obstruct the street view from the landing, two wooden lattices are placed between the posts. On these wooden lattices, there are geometric wooden decorations. The underside of the balcony is divided into arch-shaped segments. The spandrels of the arches are decorated with painted vegetal motifs. On the triangular pediment, the inscription 'Maşallah' is visible, while at the center of the arch row on the first floor, the inscription 'Sene 1323' (A.D. 1905) can be read. The second floor is designed as a cantilevered projection. The underside of the projection is clad in wood and decorated with zigzag-shaped woodwork at the edge. Rectangular guillotine windows are used on both the first and second floors. On the roof, the transverse rectangular-plan cihannüma includes rectangular colored-glass windows beneath a profiled eave.

The hipped roof is covered with traditional Turkish pantiles and zinc sheets, while the underside of the eaves is lined with wood.
