**BOLU TAŞINMAZ KÜLTÜR VE TABİAT VARLIKLARI ENVANTERİ****MUDURNU İLÇESİ - SİVİL MİMARİ YAPILAR**

| ADI | Pamuklar Evi-Konut | | |

| BOLU IMMOVABLE CULTURAL AND NATURAL HERITAGE INVENTORY | | | |
| NAME | Pamuklar House-Residence | | |

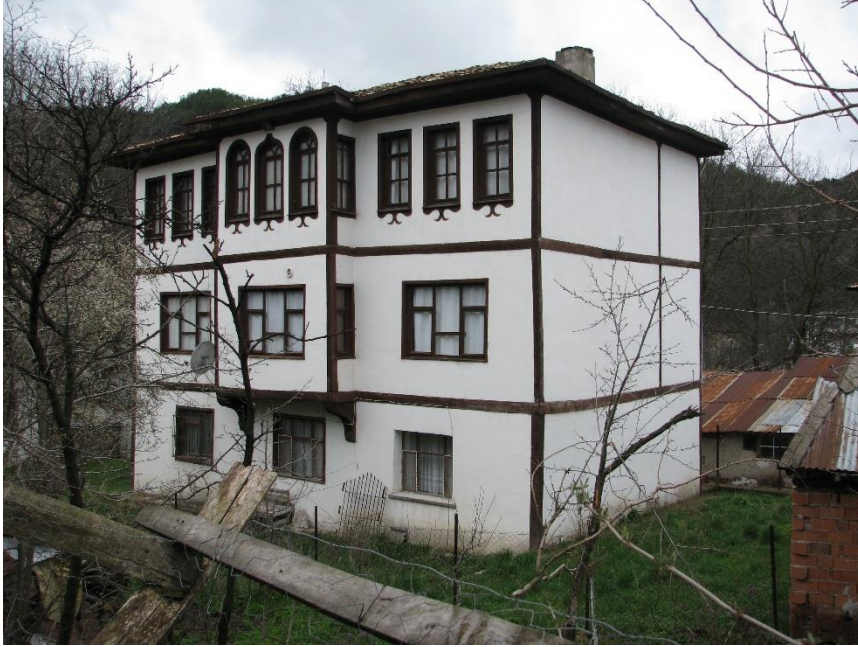
Pamuklar Evi, Bolu Müze Müdürlüğü Arşivi

Bolu İli, Mudurnu İlçesi, Kaygana Mahallesi, 26-30-Za pafta, 126 ada, 3 parselde yer alan zemin + 2 katlı yapı, bahçe içerisinde yer almaktadır. Yapı tekniği ahşap karkas arası dizme üstü sıvalıdır. Yapıya giriş merdivenlerle çıkılan 2 kapıdan sağlanmaktadır. Ön cephede 1. ve 2. kat boyunca yükselen çıkma, profilli ahşap konsollarla desteklenmiştir. Giriş cephesi üzerinde yapının sağ tarafında havalandırma pencereleri, sol tarafında giyotin tarzı dikdörtgen pencereler, çıkma üzerinde ise İspanyol tipi pencere bulunmaktadır. Sağ ve sol cepheler sağır bırakılmıştır. Arka cephede de giriş cephesinde olduğu gibi 1. ve 2. kat üzerinde, ortada ahşap konsollarla desteklenen çıkma yer almıştır. Zemin kat ve 1. katta İspanyol tipi pencere, 2. katta ise pencere denizliklerinin altı ahşap bezemeli giyotin tarzı dikdörtgen pencereler bulunmaktadır.

Kırma çatısı alaturka kiremitle örtülüdür ve geniş saçaklıdır.

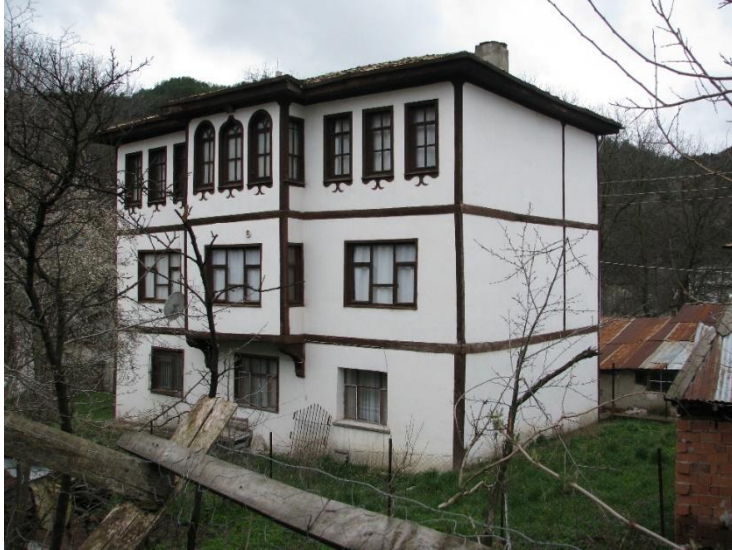
| BOLU IMMOVABLE CULTURAL AND NATURAL HERITAGE INVENTORY | | | |
|---|---|---|---|
| Pamuklar House, Bolu Museum Directorate Archive | | | |

| BOLU IMMOVABLE CULTURAL AND NATURAL HERITAGE INVENTORY | | | |
|---|---|---|---|
| <p>The two-fold building with a ground floor, located in Bolu Province, Mudurnu District, Kaygana Neighborhood, sheet 26-30-Za, Block 126, Plot 3, is situated in a garden. The construction technique consists of a wooden frame with infill, covered with plaster. Access to the building is provided through two doors reached by a set of stairs. On the front façade, a cantilevered projection extending across the first and second floors is supported by a wooden bracket (timber column). On the entrance façade, there are ventilation windows on the right side, guillotine-style rectangular windows on the left side, and a Spanish-style window on the corbel above. The right and left façades are blind. On the rear façade, like the front, there is a central corbel on the first and second floor supported by a wooden bracket (timber column). On the ground floor and first floor, there are Spanish-style windows, while on the second floor, there are rectangular guillotine-style windows with wooden ornamentation below the windowsill.</p> <p>The roof is hipped and covered with traditional Turkish pantiles.</p> | | | |
