**BOLU TAŞINMAZ KÜLTÜR VE TABİAT VARLIKLARI ENVANTERİ****MUDURNU İLÇESİ - DİNİ KÜLTÜREL YAPILAR**

| ADI | Hatice Hatun Cami | | |

**BOLU IMMOVABLE CULTURAL AND NATURAL HERITAGE INVENTORY****MUDURNU DISTRICT – RELIGIOUS CULTURAL STRUCTURES**

| NAME | Hatice Hatun Mosque | | |

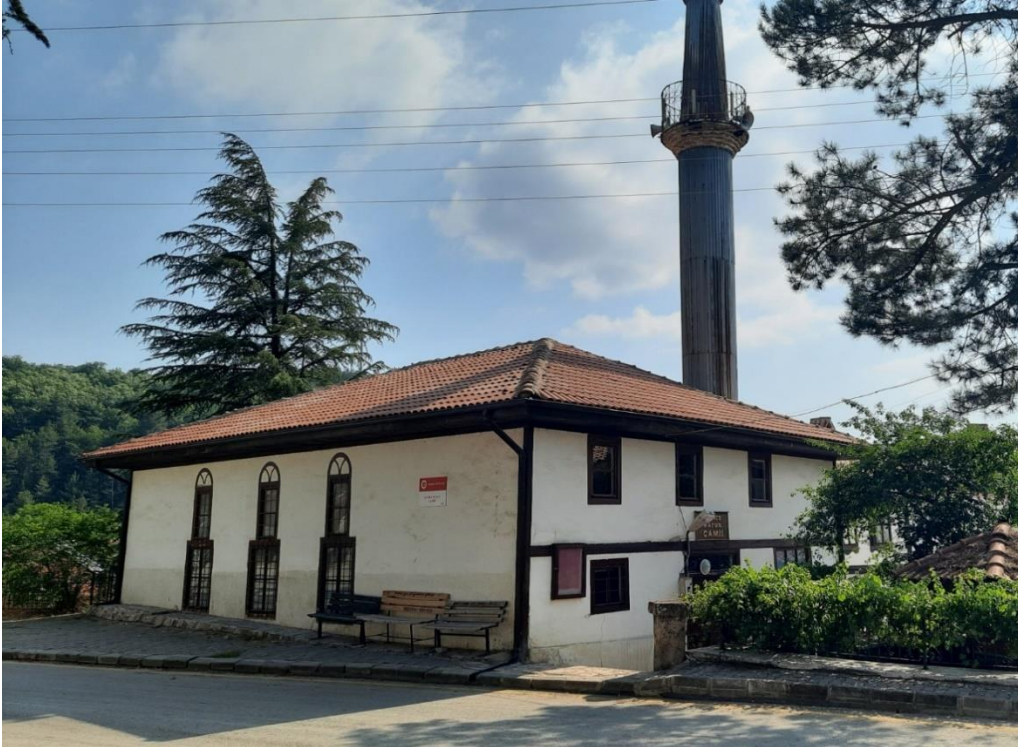
Bolu İli, Mudurnu İlçesi, Hızırfağı Mahallesi, Taşmektep Sokak, 30-27-Ad pafta, 208 ada, 1 parselde bulunmaktadır. Enlemesine dikdörtgen planlı, kırma çatılı taş temel üzeri ahşap + kerpiç yapıdır. Yapının Ankara caddesine bakan cephesinde 6 adet demir parmaklıklı dikdörtgen forumlu pencere yer alır. Kuzey cephesinde zemin hizasında ortada yenilenmiş çift kanatlı ahşap kapı bulunmaktadır. Girişin iki yanında demir parmaklıklı 1 er pencere onların üzerinde de yine ahşap şöveli dikdörtgen pencere açıklığı bulunmaktadır. Yapının yenilenmiş mimarisi tek şerefeli olup, gövde ve külâh çinko kaplıdır. Yukarıya doğru incelen bir yapıdır. Haremi örten ahşap basık çitakari işçilikli tavanın geometrik bezemeli bir göbeği vardır.

Hatice Hatun Cami, Bolu Müze Müdürlüğü Arşivi

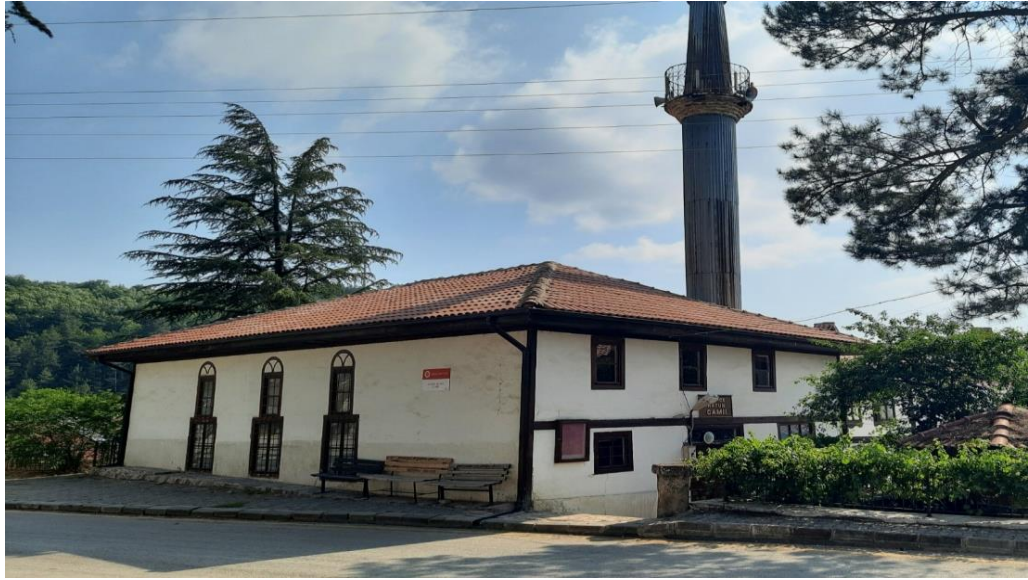
The structure is located at Plot 1, Block 208, Sheet 30-27-Ad, Taşmektep Street, Hızırfağı Neighborhood, Mudurnu District, Bolu Province, Türkiye. It is a Transversely rectangular-plan structure, featuring a hipped-roof built on a stone foundation with a timber frame and adobe infill. The façade of the structure facing Ankara Street features 6 iron-barred rectangular formed windows. On the north façade, at ground level, there is a double-leaf wooden door. On both sides of the entrance, there is one iron-barred window each, and above them, there appears a wooden-framed rectangular window opening. The structure's only renovated part it has only one şerefe, which is the balcony of a minaret, where the müezzin, who is the person who calls muslims to prayer, does the call, named ezan. The body and the cone is covered with zinc. The structure tapers upwards. The low ceiling, with an incised carving that covers the harem, has a geometrically decorated central medallion.

Hatice Hatun Mosque, Bolu Museum Directorate Archive
