**BOLU TAŞINMAZ KÜLTÜR VE TABİAT VARLIKLARI ENVANTERİ****MUDURNU İLÇESİ - SİVİL MİMARİ YAPILAR**

| ADI | Dombaylar Evi-Konut | | |

**BOLU IMMOVABLE CULTURAL AND NATURAL HERITAGE INVENTORY****MUDURNU DISTRICT – CIVIL ARCHITECTURE DISTRICT**

| <b>NAME</b> | Dombaylar House-Residence | | |

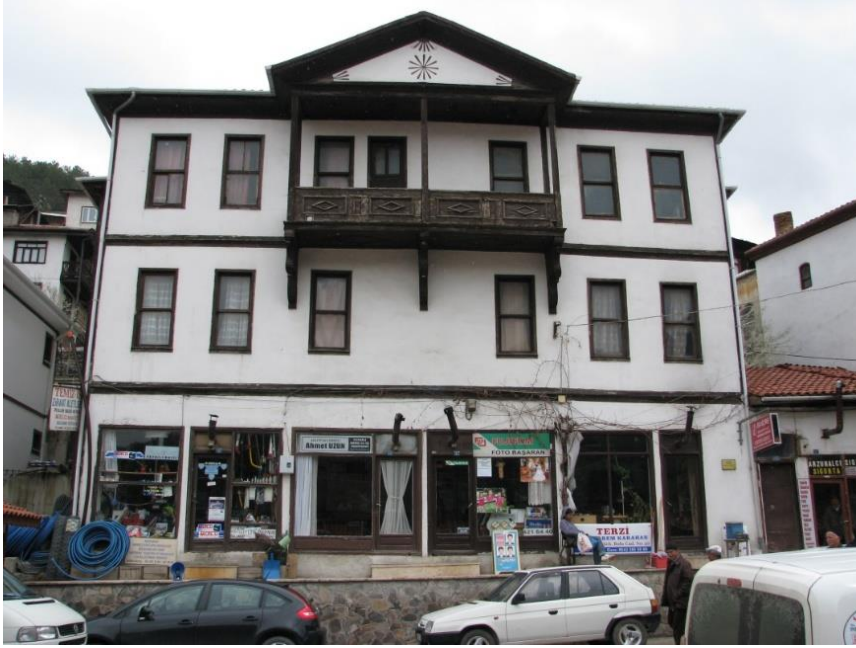
Dombaylar Evi, Bolu Müze Müdürlüğü Arşivi

Bolu İli, Mudurnu İlçesi, Seyrancık Mahallesi, 26-30-Zb pafta, 14 ada, 2 parselde yer alan ahşap bina, zemin + 2 katlıdır. Yapı, ahşap karkas arası dizeme üstü sıvalıdır. Binanın çift kanatlı ve ahşap 2 giriş kapısı bulunmaktadır. Zemin katta ticarethane olarak kullanılan camekanlı mekanlar mevcuttur. 1. katta ikişerli gruplar halinde 6 tane dikdörtgen pencere yer alır. 2. katta yer alan 3 ahşap konsolla desteklenen balkon ahşap korkuluklu ve geometrik süslemelidir. Balkondan çıkan dikmeler, üstte çatının uzatılıp profilendirilmesiyle oluşan üçgen alınlığı destekler. Balkonun sağında ve solunda ikişer tane dikdörtgen giyotin pencere bulunur. Sol yan cephede 1. katta tüm bina boyunca devam eden bir çıkma yer alır. Kat aralarında ahşap hatıllar, köşelerde ahşap dikmeler bulunmaktadır.

Çatı kırma ve alaturka kiremit kaplı olup, saçak altı ahşap kaplamadır.

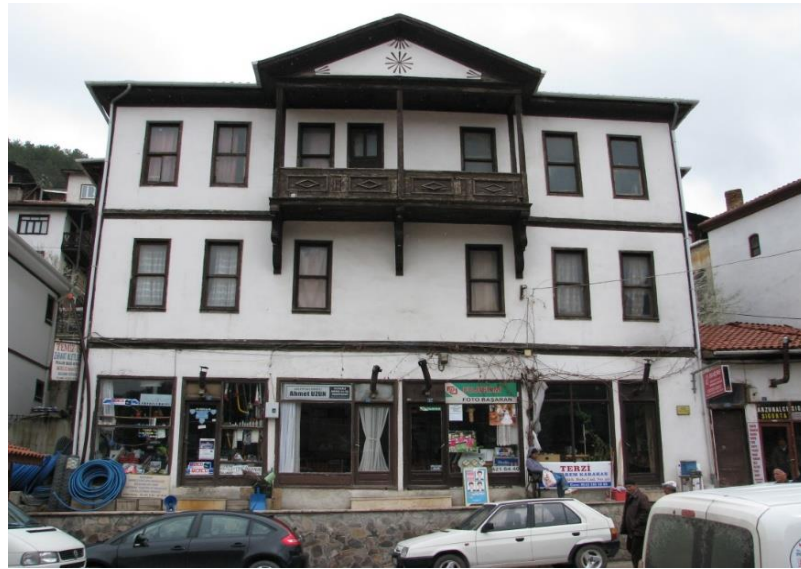
Dombaylar House, Bolu Museum Directorate Archive

The structure located on Sheet 26-30-Zb, Block 14, Plot 2, in Bolu city, Mudurnu district, Seyrancık Neighborhood, is a two-storey structure with a ground floor. The construction technique consists of plastered masonry infill between a wooden frame. Access is provided through two double-leaf wooden doors. The ground floor features rooms with glass panels, used for commercial purposes. The first floor features six rectangular windows arranged in groups of two. The balcony on the second floor, supported with three wooden brackets, is a balcony with wooden railing, has a wooden railing decorated with geometric patterns. The studs extending from the balcony support the triangular-pediment formed by the extended and profiled roof above. The balcony features rectangular guillotine windows in pairs, both on the left side and the right side of it. The left side of the facade features a cantilevered projection all along the building. Timber tie beams are present between the floors, and wooden posts are used at the corners.

The eaves soffit of the building, which has a hipped roof covered with pantiles, is wood-clad.
