**BOLU TAŞINMAZ KÜLTÜR VE TABİAT VARLIKLARI ENVANTERİ****MUDURNU İLÇESİ - SİVİL MİMARİ YAPILAR**

| ADI | Hacı Tahsin Beyler Evi-Konut | | |

**BOLU IMMOVABLE CULTURAL AND NATURAL HERITAGE INVENTORY****MUDURNU DISTRICT – CIVIL ARCHITECTURE STRUCTURES**

| NAME | Hacı Tahsin Beyler House-Residence | | |

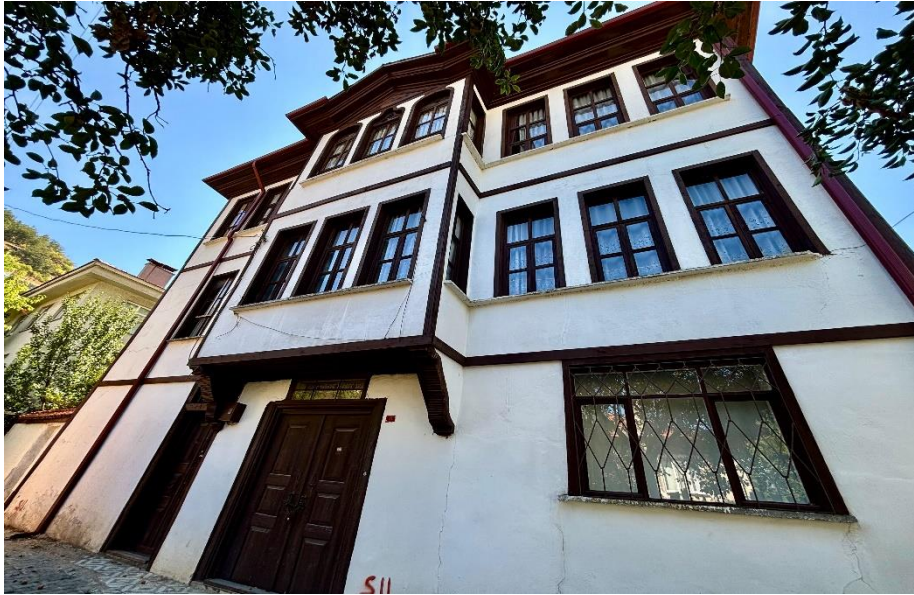
Hacı Tahsin Beyler Evi, Bolu Müze Müdürlüğü Arşivi

Bolu İli, Mudurnu İlçesi, Büyükcami Mahallesi, Taşköprü Sokak, 26-30-Zc pafta, 167 ada, 16 parselde yer alan yapı zemin + 2 katlıdır. Yapı tekniği ahşap karkas arası dizeme üstü sıvalıdır. Taşköprü Sokaktan çift kanatlı ahşap bir kapı ile girilir. Kapı üstünde ince uzun bir ışıklık vardır. 1. katta kapının üstünde iki ahşap konsolla desteklenen çıkma 2. katta da devam etmektedir. Çıkmanın altı ahşap kaplamadır. Saçak uzantısı şekillendirilerek çıkmayla üçgen alınlık şekline dönüştürülmüştür. Zemin katta sağda İspanyol tipi pencere, 1. ve 2. katlarda dikdörtgen formlu giyotin tarzı pencereler bulunmaktadır. Sağ yan cephe sağırdır. Binanın yüzeyine beton sıva yapılmış ve pencere önlerine beton denizlik dökülmüştür.

Kırma çatı alaturka kiremitle örtülü olup, saçak altı ahşap kaplamalıdır.

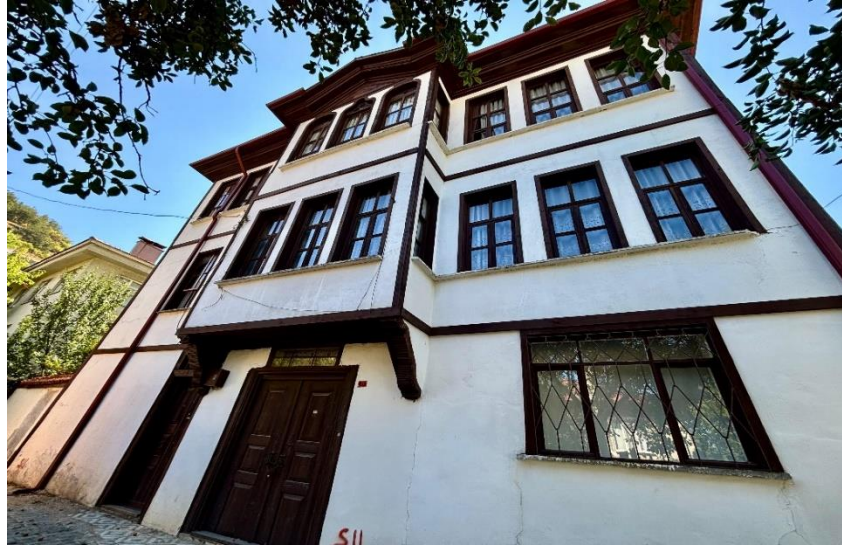
Hacı Tahsin Beyler House, Bolu Museum Directorate Archive

The building, located in Bolu Province, Mudurnu District, Büyükcami Neighborhood, Taşköprü Street, sheet 26-27-Db, block 167, plot 16, consists of a ground floor and two upper floors. The construction technique consists of a wooden frame with infill, covered with plaster. The entrance is with a double-leaf wooden door from Taşköprü Street. Above the door, there is a long and narrow transom window. On the first floor, above the door, a cantilevered projection is supported by two wooden brackets, and it continues on the second floor. The underside of the cantilevered projection is clad in wood. The eaves have been shaped to form a triangular pediment in harmony with the cantilevered projection. On the ground floor, to the right, there is a Spanish-style window; on the first and second floors, there are rectangular guillotine windows. The right side façade is blind. The exterior surface of the building has been covered with concrete plaster, and concrete sills have been cast beneath the windows.

The hipped roof is covered with traditional Turkish pantiles, and the undersides of the eaves are clad in wood.
