**BOLU TAŞINMAZ KÜLTÜR VE TABİAT VARLIKLARI ENVANTERİ****MUDURNU İLÇESİ - SİVİL MİMARİ YAPILAR**

| ADI | Hatice KAYA Evi-Konut | | |

**BOLU IMMOVABLE CULTURAL AND NATURAL HERITAGE INVENTORY****MUDURNU DISTRICT – CIVIL ARCHITECTURE DISTRICT**

| NAME | Hatice KAYA House-Residence | | |

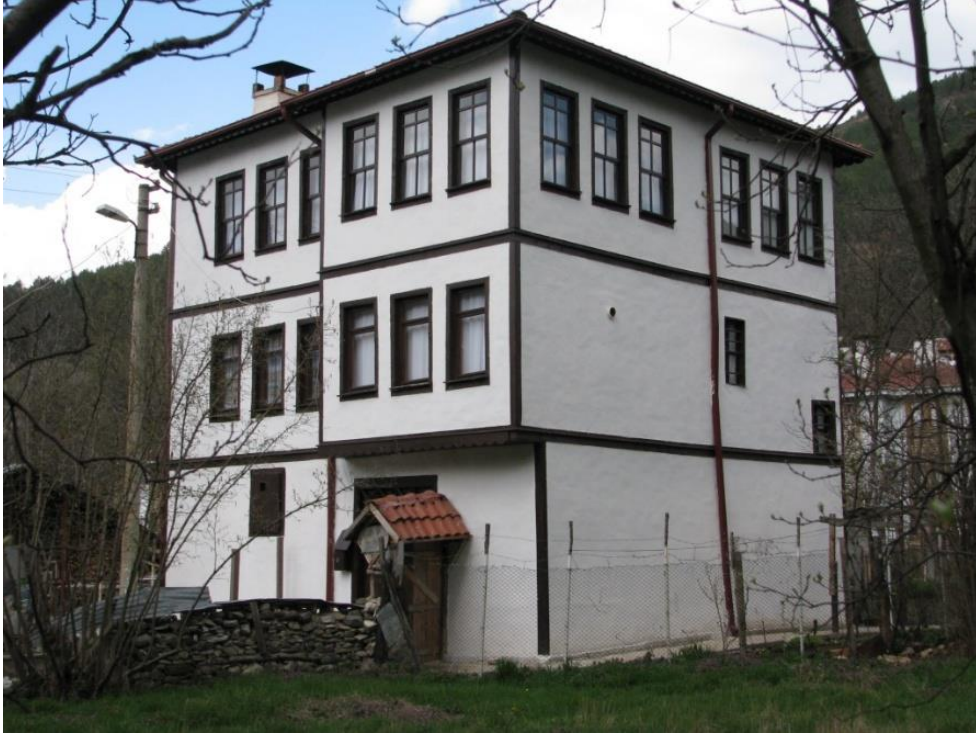
Hatice KAYA Evi, Bolu Müze Müdürlüğü Arşivi

Bolu İli, Mudurnu İlçesi, Hızırfakı Mahallesi, Çaykenarı Sokak, 30-27-Ia pafta, 224 ada, 12 parselde yer alan yapı zemin + 2 katlıdır. Yapı tekniği, taş temel üzerine, zeminde ahşap karkas arası taş dolgu, üst katlarda ise ahşap karkas arası dizeme üstü sıvadır. Yapının ana girişi batıdan çift kanatlı ahşap bir kapı ile sağlanır. Zeminde solda ahşap kepenkli bir servis penceresi mevcuttur. 1. katta sağda kapı üstünde yapılan çıkma 2. katta da devam etmektedir. Bu cephede dikdörtgen giyotin pencereler kullanılmıştır. Arka cephede 1. ve 2. katta ortada çıkma oluşturulmuş, dikdörtgen giyotin pencereler kullanılmıştır. Kat aralarında ahşap hatıl, köşelerde ise ahşap dikmeler bulunmaktadır.

Kırma çatılı ve geniş saçaklıdır.

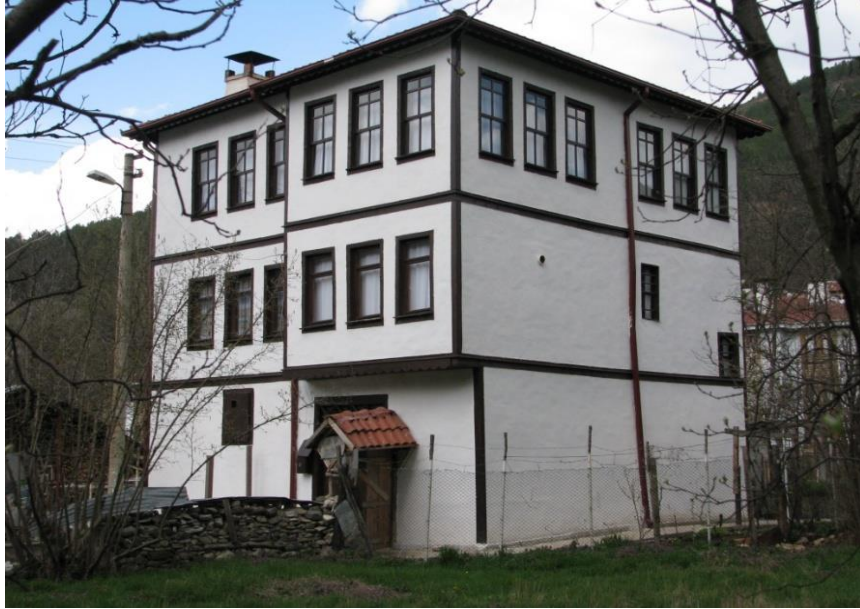
Hatice KAYA House, Bolu Museum Directorate Archive

The structure located on Sheet 30-27-Ia, Block 224, Plot 12, in Bolu city, Mudurnu district, Hızırfağı Neighborhood, Çaykenarı Street is a two-storey building with a ground floor. The construction technique of the ground floor consists of stone infill within a wooden frame resting on a stone foundation while the upper floors feature plastered masonry infill within a wooden frame. The main entrance to the building is through a double-leaf wooden door located on the west side. A pass-through window with a wooden shutter is located on the left side of the ground floor. The cantilevered projection above the door on the first floor extends to the second floor as well. This facade features rectangular guillotine windows. On the rear facade, another cantilevered projection is positioned in the middle of the first and second floors. Rectangular guillotine windows are also present here. Timber tie beams are installed between the floors, and wooden posts are utilized at the corners.

The structure has a hipped roof with wide eaves.
