**BOLU TAŞINMAZ KÜLTÜR VE TABİAT VARLIKLARI ENVANTERİ****MUDURNU İLÇESİ - SİVİL MİMARİ YAPILAR**

| ADI | Hayrettin ULU – Bülent ÖZASLAN Evi-Konut | | |

**BOLU IMMOVABLE CULTURAL AND NATURAL HERITAGE INVENTORY****MUDURNU DISTRICT – CIVIL ARCHITECTURE DISTRICT**

| <b>NAME</b> | Hayrettin Ulu – Bülent Özaslan House-Residence | | |

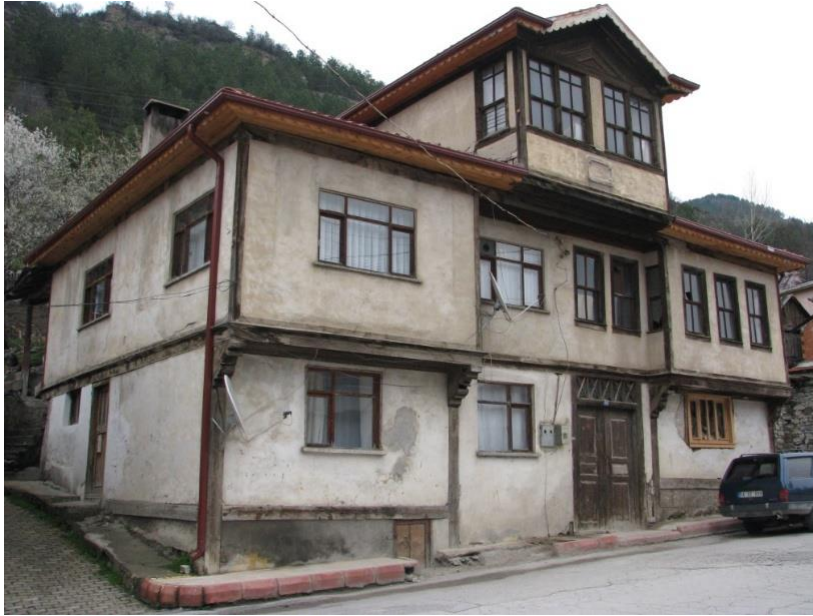
Hayrettin ULU – Bülent ÖZASLAN Evi, Bolu Müze Müdürlüğü Arşivi

Bolu İli, Mudurnu İlçesi, Büyükcami Mahallesi, 26-27-Db pafta, 183 ada, 3 - 4 parselde yer alan bina, zemin + 1 katlıdır. Cihannüma katı da mevcuttur. Yapı tekniği, taş zemin üstünde ahşap karkas arası dizeme üstü sıvadır. Ankara Caddesinden çift kanatlı ahşap kapı ile girişi sağlanan binanın zemin katında İspanyol tipi pencereler vardır. 1. katta sağda ve solda iki ahşap dilimli konsolla desteklenen köşe çıkmaları yapılmıştır. 2. katta sağ tarafta ve sağ cephede dikdörtgen formlu, sol tarafta ve sol cephede İspanyol tipi pencereler bulunmaktadır. Çatıda yer alan beşik çatıyla örtülü cihannümanın saçak altı üçgen alınlıklı şekilde çıtakari işlenmiştir. Köşkte dikdörtgen giyotin pencereler yer almaktadır. Cihannümanın ön cephesinde pencere altında dikdörtgen bir kartuş vardır. Kat aralarında ahşap hatıllar, köşelerde ahşap dikmeler kullanılmıştır. Sağ cephede zemin kat duvarı hariç, tüm yapı sıvalıdır.

Çatısı kırma ve alaturka kiremitle kaplı olan binanın saçak altı ahşap kaplanmıştır.

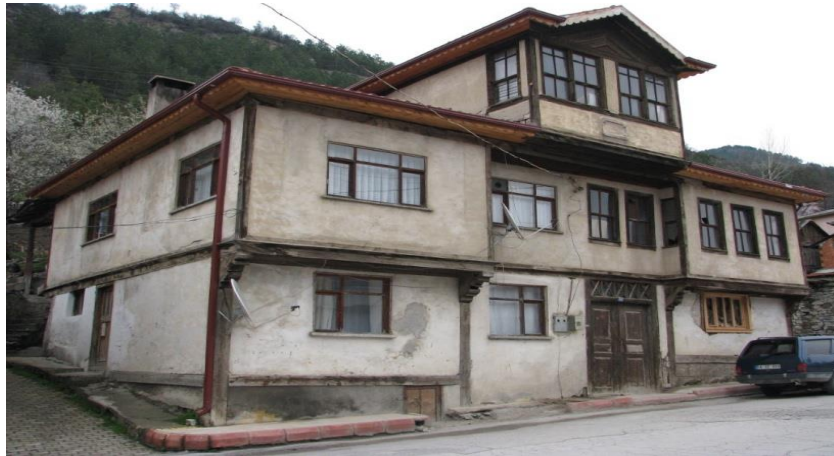
Hayrettin Ulu – Bülent Özaslan House, Bolu Museum Directorate Archive

The structure located on Sheet 26-27-Db, Block 183, Plot 3-4, in Bolu City, Mudurnu District, Büyükcami, Neighborhood, is a one-storey building with a ground floor. It also includes an upper-level room, which is typical of traditional Ottoman architecture. The construction technique consists of plastered masonry, supported by a wooden frame resting on a stone foundation. The building with its entrance through a double-leaf wooden door from Ankara Street features Spanish-style windows on the ground floor. On the first floor, in the left corner, a cantilevered projection supported by two wooden segmented consoles has been constructed. On the second floor, rectangular windows are located on the right side and right façade, while Spanish-style windows are present on the left side and left façade. The eaves of the upper-level room situated on the roof covered with a saddle roof are decorated with traditional Ottoman-style fine woodwork and triangular pediments. Rectangular-shaped guillotine windows are present in the pavilion. On the front facade of the upper-level room, there is a rectangular cartouche beneath the window. Timber tie beams are used between the floors, and wooden posts are present at the corners. On the right side façade, the entire structure is plastered except for the ground floor wall.

The building has a hipped roof covered with traditional Turkish-style pantile, and its eaves are wood-clad.
