BOLU TAŞINMAZ KÜLTÜR VE TABİAT VARLIKLARI ENVANTERİ

MUDURNU İLÇESİ - SİVİL MİMARİ YAPILAR

ADI	Hayriye ÇETİN- Mesure ONURLU Evi-Konut		
ENVANTER NO	12	KADASTRAL DURUMU	
İLİ	Bolu	PAFTA	26-30-Zd
İLÇESİ	Mudurnu	ADA	52
MAHALLESİ	Seyrancık Mahallesi	PARSEL	6-8
TESCİL DURUMU	Ankara Kültür ve Tabiat Varlıklarını Koruma Kurulu'nun 16.10.1995 tarih ve 4219 sayılı kararı ile tescil edilmiştir.

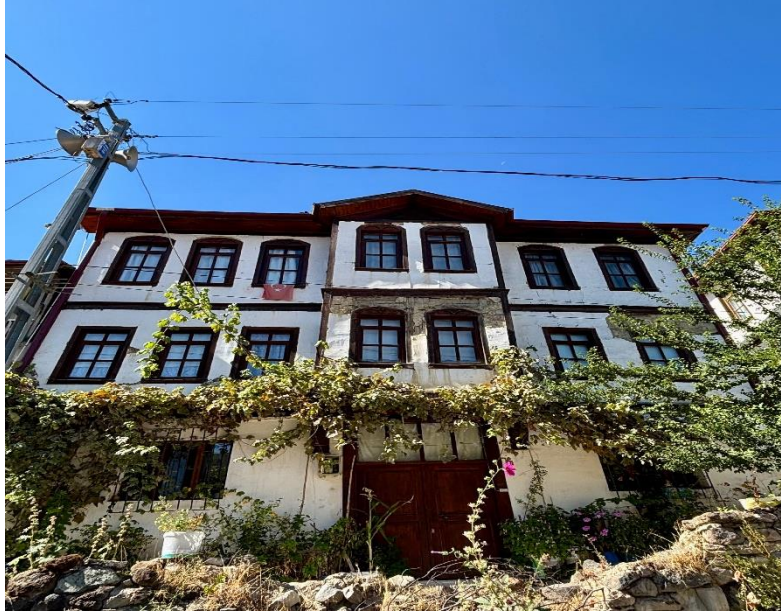
Hayriye ÇETİN- Mesure ONURLU Evi, Bolu Müze Müdürlüğü Arşivi

Bolu İli, Mudurnu İlçesi, Seyrancık Mahallesi, 26-30-Zd pafta, 52 ada, 6-8 parselde bulunan yapı, zemin + 2 katlıdır. Yapı tekniği; zeminden taş temel üstüne karkas arası kerpiç dolgu, üst katlar ahşap karkas arası dizeme üstü sıvalıdır. Köprübaşı sokağından çift kanatlı ahşap bir kapı ile girilen binanın zemin katında kapı üstünde boyunca uzanan geniş bir ışıklık bulunmaktadır. Birinci katta giriş kapısının üstünde ahşap iki konsolla desteklenen çıkma ortasında ve iki yanında geniş İspanyol tipi pencere vardır. İkinci katta ve çıkma üzerinde basık kemerli dikdörtgen pencereler mevcuttur. Yapının sol cephesi bitişik nizamlıdır. Sağ cephesi sağır olan binanın arka cephesi bahçeye açılmaktadır. Kat aralarında ahşap hatıllar, köşelerde ise ahşap dikmeler mevcuttur.

Çatı kırma ve alaturka kiremitle kaplıdır. Çatının saçakları dışa taşırılarak üçgen alınlık şeklini almış ve çıkmanın üzerini kapatmıştır. Saçak altı ahşap kaplamadır.

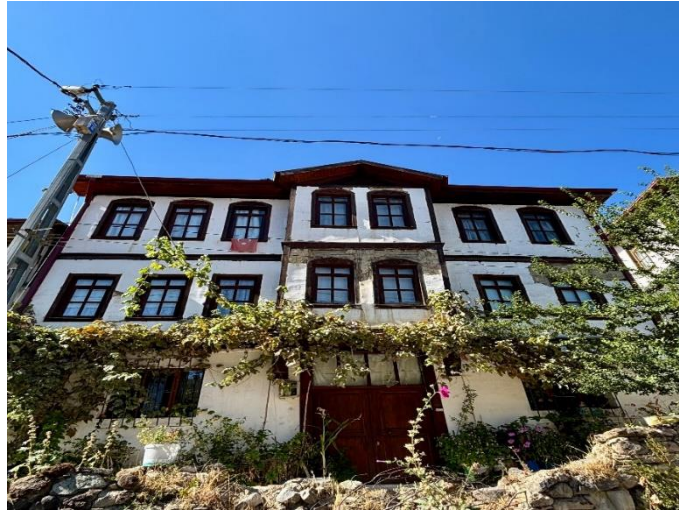
Hayriye ÇETİN- Mesure ONURLU House, Bolu Museum Directorate Archive

The building, located in Bolu Province, Mudurnu District, Seyrancık Neighborhood, sheet 26-30-Zd, block 52, plot 6-8, consists of a ground floor and two upper floors. The construction technique consists of a stone foundation at ground level with mudbrick infill above, and the upper floors feature a wooden frame with infill covered with plaster. The building, entered through a double-leaf wooden door from Köprübaşı Street, has a wide transom window extending along the top of the door on the ground floor. On the first floor, above the entrance door, there is a cantilevered projection supported by two wooden brackets, with wide Spanish-style windows in the center and on both sides. On the second floor and above the cantilevered projection, there are segmental arch rectangular windows. The left façade of the building is attached to an adjacent building. The right façade of the building is blind, while the rear opens into the garden. Wooden beams are placed between the floors, and wooden posts are located at the corners.

The roof is hipped and covered with traditional Turkish pantiles. The eaves of the roof extend outward, forming a triangular pediment shape and covering the corbel above. The underside of the eaves is clad in wood.
