BOLU TAŞINMAZ KÜLTÜR VE TABİAT VARLIKLARI ENVANTERİ

MUDURNU İLÇESİ - SİVİL MİMARİ YAPILAR

ADI	Kocalar Konağı-Konut		
ENVANTER NO	19	KADASTRAL DURUMU	
İLİ	Bolu	PAFTA	26-27-Db
İLÇESİ	Mudurnu	ADA	179
MAHALLESİ	Büyükcami Mahallesi	PARSEL	1
TESCİL DURUMU	Ankara Kültür ve Tabiat Varlıklarını Koruma Kurulu'nun 16.10.1995 tarih ve 4219 sayılı kararı ile tescil edilmiştir.

NAME	Kocalar Mansion-Residence		
ENVANTER NO	19	CADASTRAL INFORMATION	
PROVINCE	Bolu	SHEET	26-27-Db
DISTRICT	Mudurnu	BLOCK	179
NEIGHBORHOOD	Büyükcami Neighborhood	PLOT	1
REGISTRATION STATUS	It was registered by the Ankara Cultural and Natural Heritage Conservation Board with decision no. 4219 dated 16.10.1995.

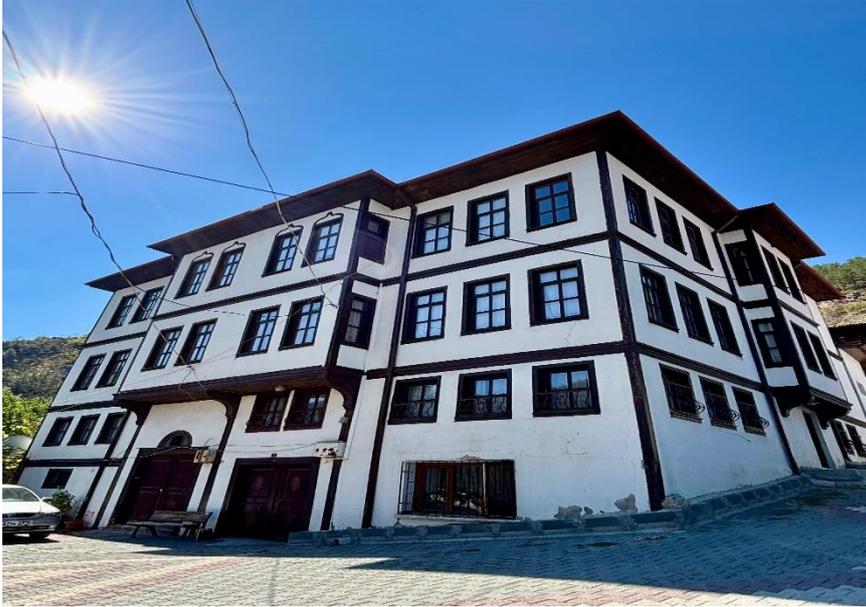
Bolu İli, Mudurnu İlçesi, Büyükcami Mahallesi, Dumlupınar Sokak, 26-27-Db pafta, 179 ada, 1 parseldeki yapı zemin + ara kat + 2 katlıdır. Kuzey yan cephesinde eğimden dolayı bina zemin + 2 kat görülmektedir. Ahşap karkas arası dizeme üstü sıvalıdır. Girişi doğuya bakan cepheden zemin kattan sağlanmaktadır. Soldaki kapı çift kanatlı ve ahşap olup, bunun yanındaki demir olarak yenilenmiştir. Yapının doğu, kuzey ve güney cephelerinde ortada 1. ve 2. kat boyunca devam eden ahşap konsollarla desteklenmiş çıkma yapılmıştır. Ön cephede çıkmanın yanına yine konsollarla desteklenmiş balkon sonradan eklenmiştir. Ara kat ve diğer katlarda İspanyol tipi pencereler görülmektedir. Pencereler binanın tümünde değiştirilmiş olup, sonradan bu hale çevrilmiştir. Kat aralarındaki hatıllar ve köşe dikmeleri ahşaptır. Yapının sıvaları yer yer dökülmüştür. Arka cepheye müstemilat eklenmiştir. Kıрма çatı alaturka kiremitle örtülü olup, geniş saçaklıdır.

Kocalar Konağı, Bolu Müze Müdürlüğü Arşivi

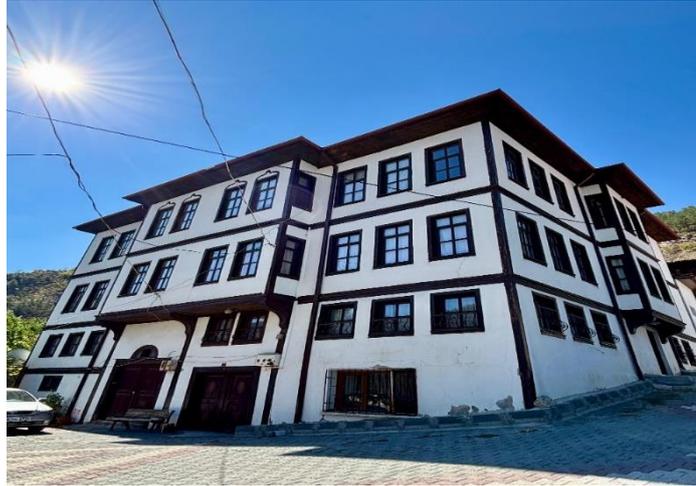
The building, located in Bolu Province, Mudurnu District, Büyükcami Neighborhood, Dumlupınar Street, sheet 26-27-Db, block 179, plot 1, consists of a ground floor, mezzanine, and two upper floors. Due to the slope on the northern side, the building is perceived as having a ground floor and two upper floors from that façade. It is constructed with a wooden frame with infill, covered with plaster. The entrance is on the east-facing façade, and access is from the ground floor. The door on the left is a double-leaf wooden door and the adjacent door has been replaced with an iron one. On the eastern, northern, and southern façades of the building, there are cantilevered projections that are supported by wooden brackets and extend through the first and second floors. A balcony, also supported by brackets, was later added to the front cantilevered projection. On the mezzanine and other floors, there are Spanish-style windows. All the windows in the building have been replaced and no longer reflect their original design.

The beams between the floors and the corner posts are made of wood. The plaster on the building has partially fallen. An annex has been added to the rear façade.

The hipped roof is covered with traditional Turkish pantiles and features wide eaves.

Kocalar Mansion, Bolu Museum Directorate Archive
