**BOLU TAŞINMAZ KÜLTÜR VE TABİAT VARLIKLARI ENVANTERİ****MUDURNU İLÇESİ - SİVİL MİMARİ YAPILAR**

| ADI | Neriman ATALAY Evi-Konut | | |

**BOLU IMMOVABLE CULTURAL AND NATURAL HERITAGE INVENTORY****MUDURNU DISTRICT – CIVIL ARCHITECTURE STRUCTURES**

| <b>NAME</b> | Neriman ATALAY House-Residence | | |

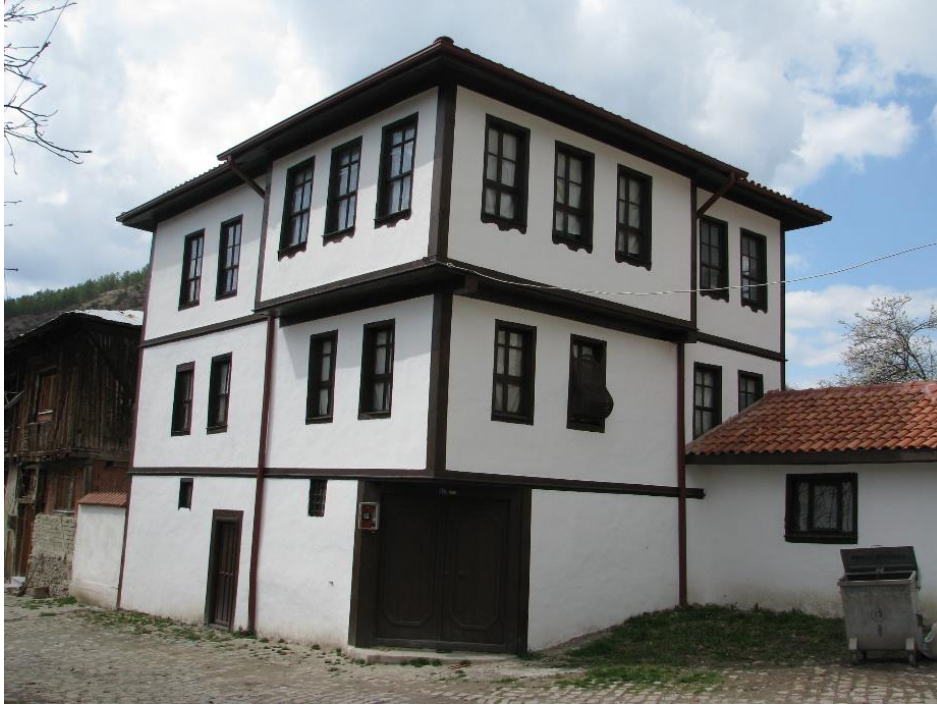
Neriman ATALAY Evi, Bolu Müze Müdürlüğü Arşivi

Bolu İli, Mudurnu İlçesi, Hızırfağı Mahallesi, Değirmen Sokak, 30-27-Ad pafta, 207 ada, 12 parselde yer alan yapı zemin + 2 katlıdır. Yapı tekniği taş temel üzeri ahşap karkas arası dizeme üstü sıvalıdır. Yapının güneydoğu köşesi zemin katta pahlanmıştır ve bu köşeden çift kanatlı ahşap bir kapı ile binaya girilmektedir. Binanın zemini doğu cephesinde sağır olup, güney cephesinde bir kapı ve iki küçük servis penceresi vardır. 2. kat güney doğu köşede altı ahşap kaplamalı çıkma şeklinde düzenlenmiştir. Yapıda zemin kat hariç dikdörtgen formu giyotin pencereler bulunmaktadır. Kat aralarında ahşap silmeler, köşelerde ahşap dikmeler vardır.

Çatı kırma ve alaturka kiremitle kaplı olup, saçak altı kaplamasızdır.

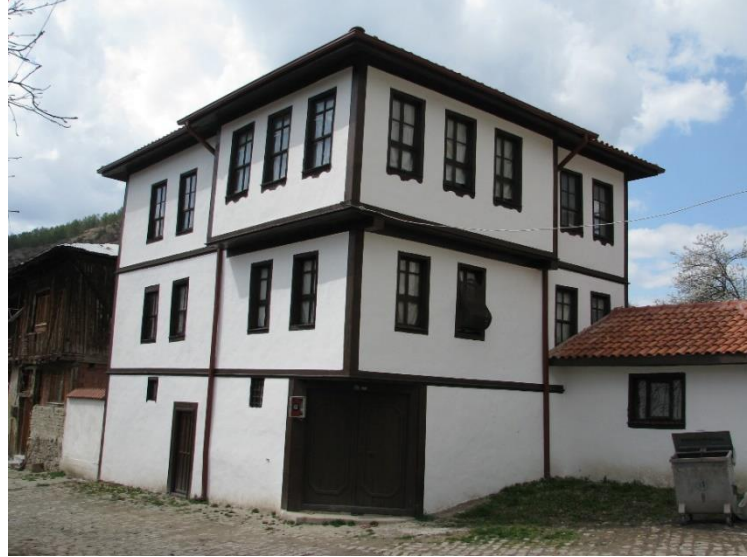
Neriman ATALAY House, Bolu Museum Directorate Archive

The building, located in Bolu Province, Mudurnu District, Hızırfağı Neighborhood, Değirmen Street, sheet 30-27-Ad, block 207, plot 12, consists of a ground floor and two upper floors. The construction technique consists of a wooden frame with infill, finished with plaster, built above a stone foundation. The southern corner of the ground floor is chamfered, and the entrance to the building is through a double-leaf wooden door at this corner. The eastern façade of the ground floor is blind, while the southern façade features a door and two small service windows. On the second floor, the southeast corner is designed as a cantilevered projection with wooden cladding underneath. Except for the ground floor, the building has rectangular-shaped guillotine windows. Between the floors, wooden moldings are used, and at the corners, there are wooden posts.

The hipped roof is covered with traditional Turkish pantiles, and the eaves are left uncovered.
